PHASE I INSPECTION REPORT

Prime River Basin (LAKE BERNARD FRANK)
MONTGOMERY COUNTY, MARYLAND
(NDI-~~MD~~-MD-0050)

PHASE I INSPECTION REPORT
NATIONAL DAM SAFETY PROGRAM

UPPER ROCK CREEK WATERSHED SITE #1
LAKF FRANK
MD 00050

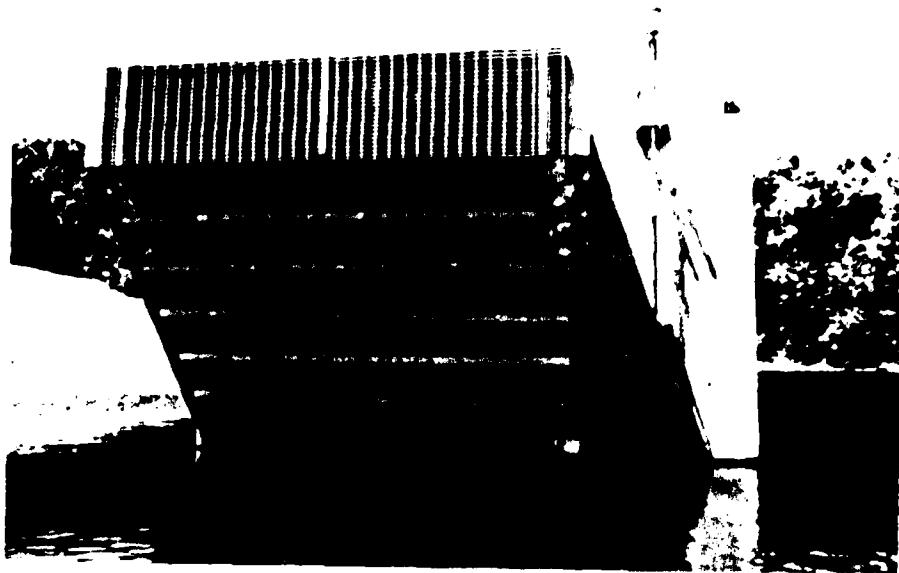
b. Appurtenant Structures. The deficiencies associated with the intake tower are causing higher than normal pool levels. Besides hampering visual inspection and routine maintenance capabilities, the designed freeboard is presently adversely affected since the present pool exceeds the S.C.S. 10 day drawdown level starting from which the Freeboard Hydrograph was applied. These considerations dictate that the deficiencies enumerated in 3.lc.3 above be rectified as soon as possible.

INTAKE TOWER

1. Re-establish the designed normal pool by clearing debris from the ungated orifices within the cold water release chamber.
2. Re-establish the operating condition of all gated orifices within the cold water release chamber and principal spillway riser.

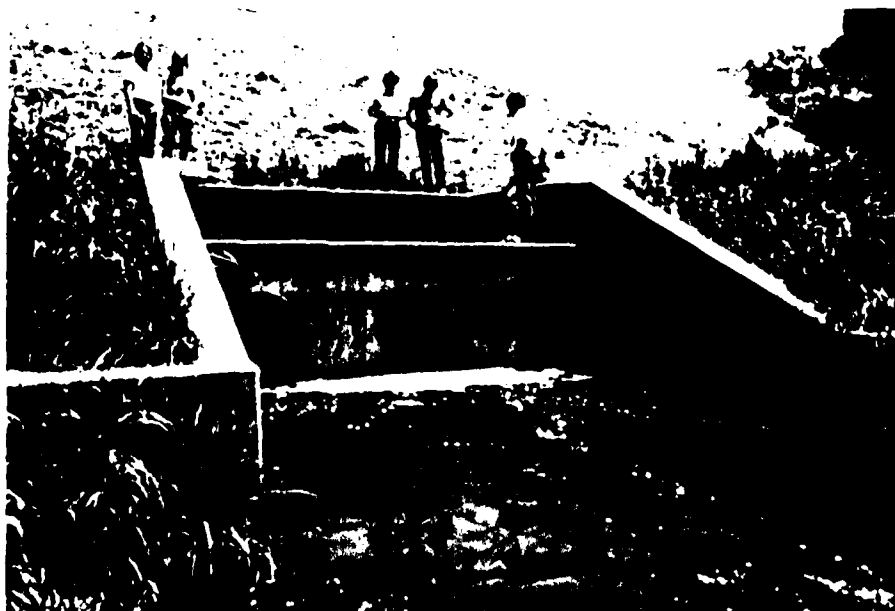
IMPACT BASIN
